DEPARTMENT OF TRANSPORTATION

Contract #: 04-0120F4Cty: SF/ALA Rte: 80 PM: 13.2/13.9File #: 69.28**WELDING INSPECTION REPORT****Resident Engineer:**Pursell, Gary**Address:** 333 Burma Road**City:** Oakland, CA 94607**Report No:** WIR-004579**Date Inspected:** 10-Nov-2008**Project Name:** SAS Superstructure**OSM Arrival Time:** 1400**Prime Contractor:** American Bridge/Fluor Enterprises, a JV**OSM Departure Time:** 2300**Contractor:** Zhenhua Port Machinery Company, Ltd (ZPMC), Changxing Island **Location:** Shanghai, China**CWI Name:** Chen Chih-Ming**CWI Present:** Yes No**Inspected CWI report:** Yes No N/A**Rod Oven in Use:** Yes No N/A**Electrode to specification:** Yes No N/A**Weld Procedures Followed:** Yes No N/A**Qualified Welders:** Yes No N/A**Verified Joint Fit-up:** Yes No N/A**Approved Drawings:** Yes No N/A**Approved WPS:** Yes No N/A**Delayed / Cancelled:** Yes No N/A**Bridge No:** 34-0006**Component:** Corner assemblies**Summary of Items Observed:**

OBG assembly bay 2

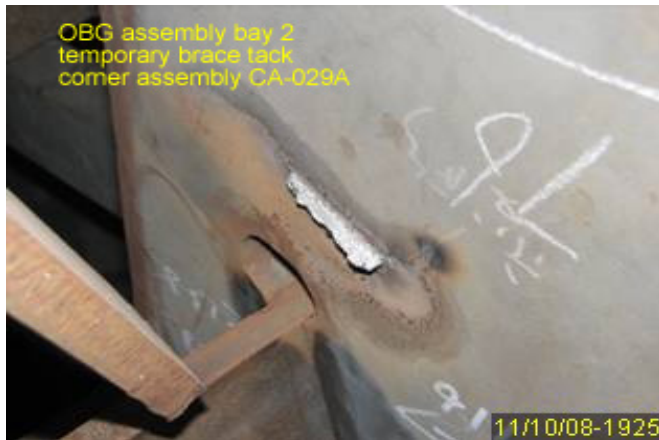
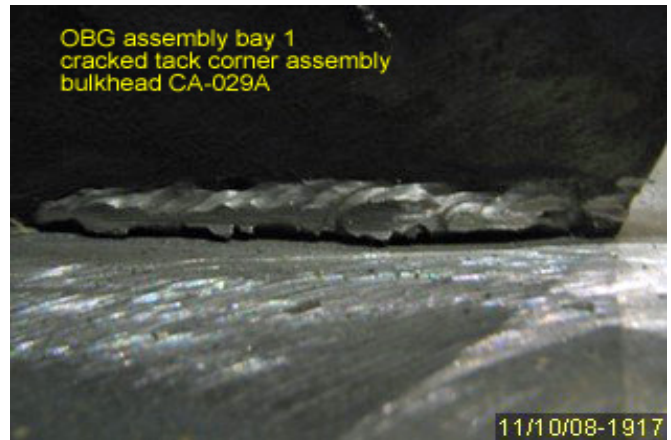
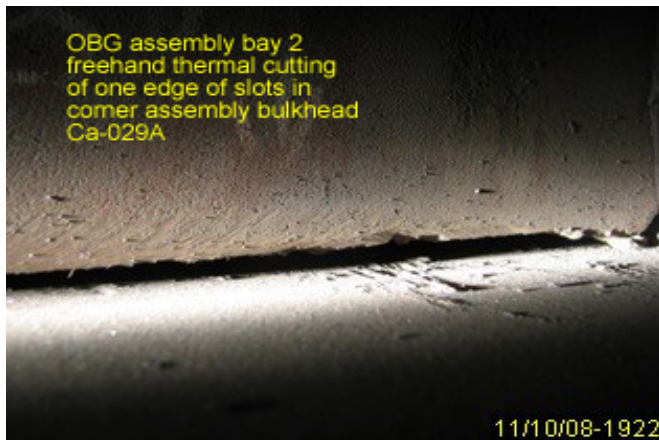
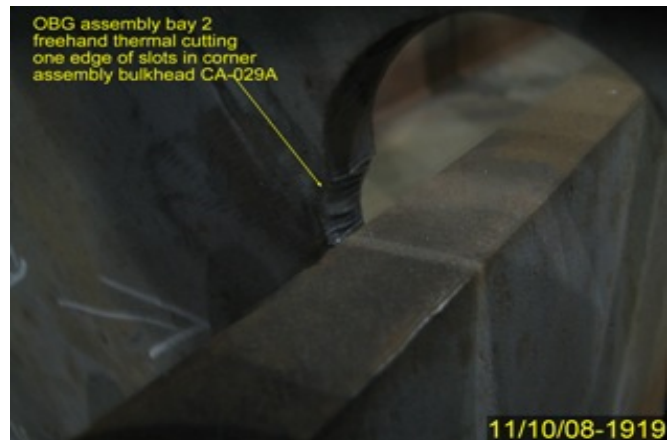
QA was informed by American Bridge Fluor (ABF) QA identified as Mr. Peter Shaw that cracked tacks were discovered on corner assembly bulk head to side panel weld joints. This QA observed and photographed cracked tacks at the following locations on corner assembly identified as CA-029A OBG section 6CW:

7 of 8 tacks cracked on bulkhead identified on material as CSD2-PP043.5.

3 of 8 tacks cracked on bulkhead identified on material as CSD2-PP044.5.

4 of 10 tacks cracked on bulkhead identified on material as CSD2-PP045.5.

During this QAs observations of the above mentioned issue, QA discovered two other issues on this corner assembly that may be of concern. QA observed that ZPMC welding personnel have tack welded temporary knee braces from the corner assembly side panel to the "SPCM" bulkheads. Contract special provisions (section 10-1.59 Shop Welding) states, welding of temporary fixtures shall be shown on the working drawings and shall conform to AWS D1.5. These temporary braces are not shown on the drawings and AWS D1.5 2002 section 12.13.1.1 states

that all tack welds used in assembly shall be located within the joint unless otherwise approved by the engineer. At this time this QA is not aware of any engineering approval to tack these braces to the SPCM material.

The second issue is concerning free hand thermal cutting of one edge of the slots in the bulkheads for clearance over the stiffeners on the side, edge and deck plates which requires engineers' approval according to AWS D1.5 2002 section 3.2.2 "Freehand thermal cutting shall be done only where approved by the Engineer". At this time this QA is not aware of any engineering approval to perform free hand thermal cutting specific to the slots in the corner assembly bulkheads. It appears as if the tack welding of temporary braces and freehand thermal cutting of the slots in the corner assembly bulkheads is present on most if not all of the corner assemblies fabricated to date. This QA has notified Caltrans QA task leaders Mr. Robert Cuellar and Mr. Albert Carreon as well as Structural Materials Representative (SMR) Mr. Peter Daughterman concerning all of the above mentioned issues Via E-mail on this date. Depending on Mr. Daughterman's response, incident reports may be forthcoming for some or all of these issues in the near future.

According to ZPMC QA identified as Mr. Testino Wang, ZPMCs technology department is currently investigating this issue and at this time has suspended further welding of the above mentioned bulkheads until a resolution to this issue can be reached.
